Causal Analysis Report

Chevron Richmond Refinery
Reportable Flaring Events

February 22, 2020
Flaring Due to Emergency Scrubber Operation

Refinery Flare Event – Cause Investigation Report

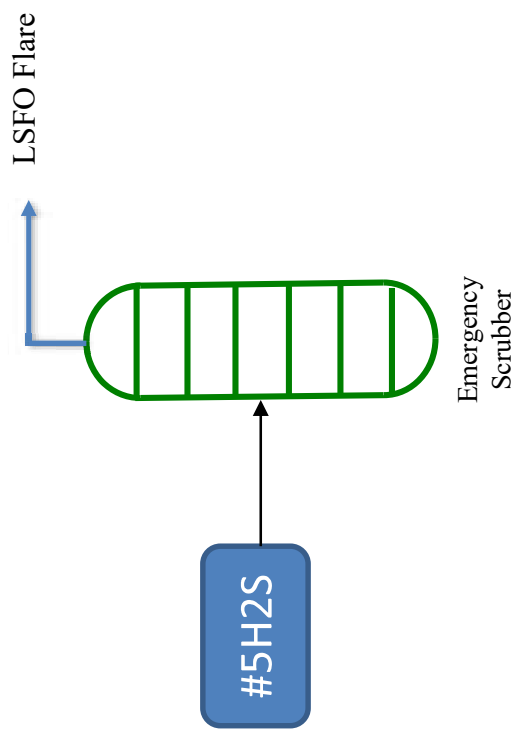
Flaring Due to Emergency Scrubber Operation

Root cause: Throughout the event, the ammonia to the emergency scrubber feed ratio was not consistent with the job aid table.

Contribution factor: The emergency scrubber vapor flow is the primary indicator of H₂S carryover. The emergency scrubber flowmeter is not reliable, and there are no alarms on the emergency scrubber overhead flow.

On February 22, 2020, while troubleshooting a plant upset, acid gas was routed to an emergency scrubber in the #5 Hydrogen Sulfide (#5 H₂S) unit of the Distillation and Refining Business Unit. The ammonia flow ratio into the emergency scrubber bottoms recirculation system was insufficient for absorption, and the emergency scrubber overhead vapor flow went to the relief system. Flaring began at approximately 12:53 PM at the Low Sulfur Fuel Oil (LSFO) flare. The primary source of vent gas flared during this event was process material from the #5 H₂S unit. Operations immediately began to troubleshoot to reduce acid gas flow to relief, and as a result, flaring ceased at approximately 4:40 PM. The sulfur dioxide (SO₂) emissions from the LSFO flare exceeded 500 pounds (lbs) on February 22, 2020.

1. Repair the emergency scrubber overhead vapor flow meter.
Projected completion date: 7/31/2020
2. Add an alarm for the emergency scrubber overhead vapor flow.
Projected completion date: 2/28/2021
3. Convert job aid to startup emergency scrubber into a procedure.
Projected completion date: 10/31/2020
4. Deliver emergency scrubber refresher training to board operators.
Projected completion date: 12/31/2020
